Report No. CG-D-07-99

**Evaluating a Protocol for Testing a Fire Resistant
Oil Spill Containment Boom**

**FINAL REPORT
FEBRUARY 1999**

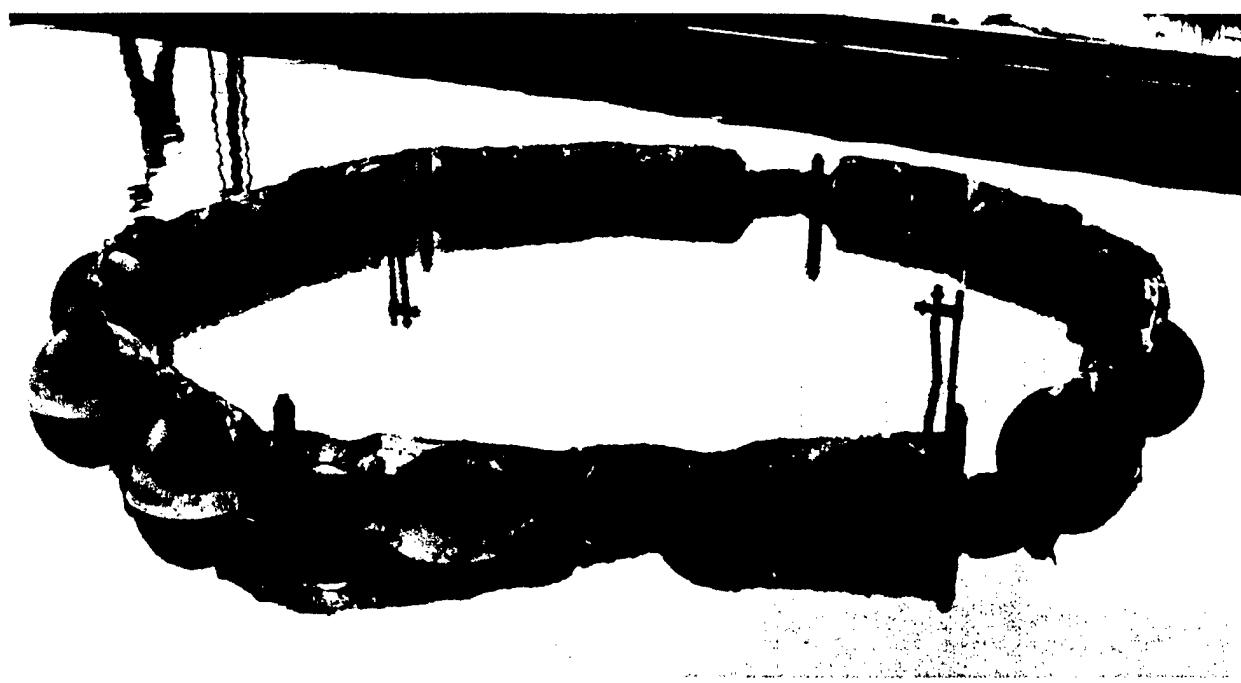
Figure 13. Boom 1, after burning

Boom	Observations	Notes
1	Degradation of the fabric coating, fabric substrate visible	Abrasion and tears in the area of the stanchions
2	Loss of sacrificial cover, some degradation of the fabric beneath the metal mesh near the joints	Small fuel leak at connector after burn 1
3	Damage to the cover and flotation in a portion of the boom, no visible change to the rest of the boom	Test terminated after the first burn when the cooling water was shut down
4	Tears and holes in the boom on the downwind side	
5	Loss of sacrificial cover, tears in the fabric along some of the coils	Abrasion and tears in the area of the stanchions - test terminated after 1 hour of burning

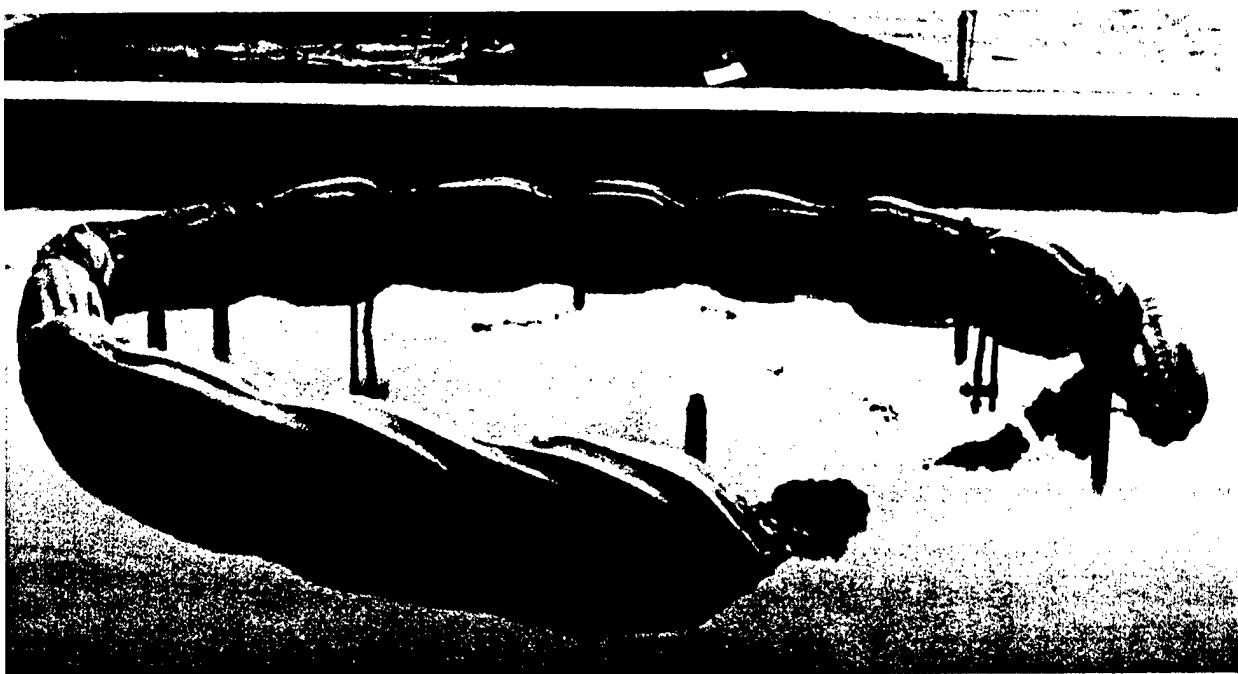
Figure 21. Boom 3, after burning

The events observed for the four non-water cooled booms followed the expected protocol. There were several issues related to the water-cooled boom 3, which resulted in differences when compared with the non-water cooled booms. During burn 1, the hose supplying water to the boom became disconnected from the boom. The loss of cooling water led to a loss of buoyancy in part of the boom on the downwind side resulting in a fuel leak and sustained burning outside the boom. Since the boom could no longer contain oil, the test was terminated. For burn 2, a new section of boom was used. Fuel was added to the boom at the same rate per unit area as for the non-water cooled booms. During the burn, it was observed that the fire appeared substantially smaller than for the non-water cooled booms. At the end of an hour the fire did not burn out, but rather, continued for a total of almost two hours. The cooling water for the boom was being drawn from a drain at the bottom of the tank. The water passed through a large filter provided by the manufacturer before entering the boom. Over the course of two hours, small rust particles in the water loaded the filter to the point where water flow to the boom was restricted. Although the fire was still burning, it was decided to shut down the cooling water and change the filter. A fire hose was used in an attempt to cool the boom, but it did not appear to be effective. Water flow was restored to the boom after approximately three minutes, but within five minutes, a part of boom on the downwind side lost buoyancy and sustained burning was observed outside the boom. This continued until the unknown quantity of remaining fuel within the boom was consumed. No third burn was conducted on boom 3.
